PHASE I INSPECTION REPORT NATIONAL DAM SAFETY PROGRAM

SEPTEMBER 1978

NAME OF DAM: CRYSTAL

Name of Dam: Crystal
State: Virginia
County: Frederick
Stream: Keckley Run
Date of Inspection: 20 July 1978

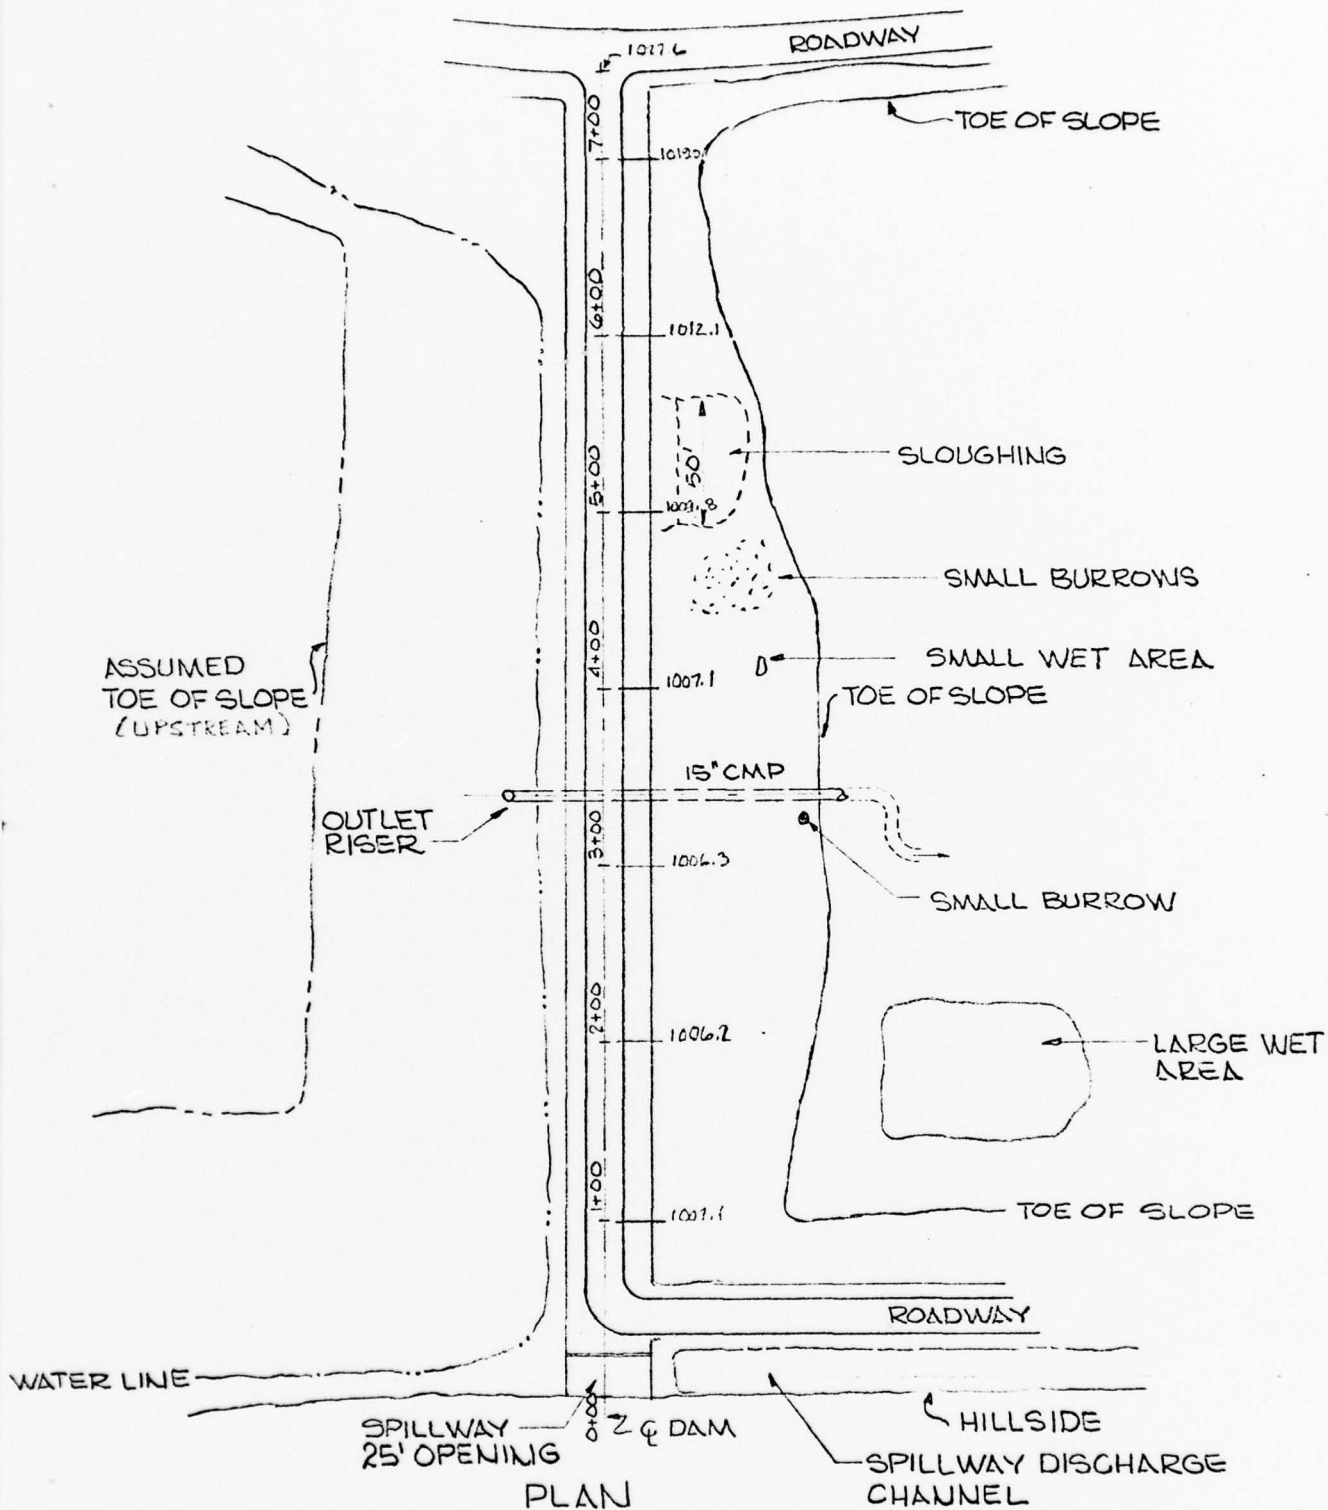
MICHAEL BAKER JR. INC.
CRYSTAL LAKE DAM
PLATE I
8-15-78

NOTE: NO EMERGENCY
DRAIN WAS FOUND

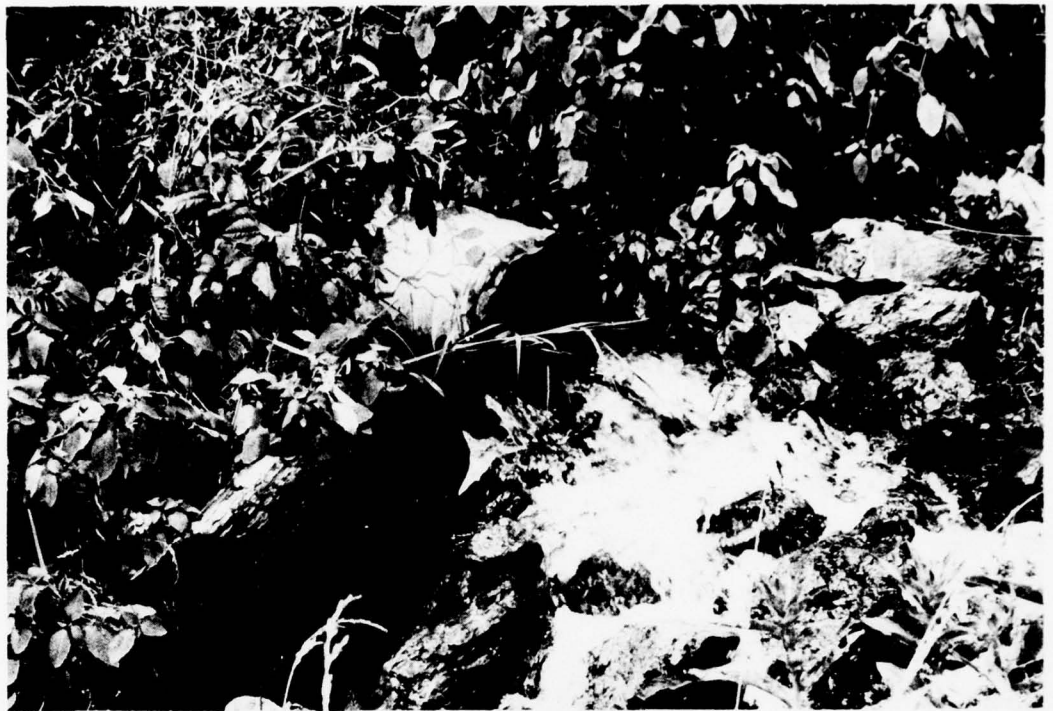
- 3.1.3 Appurtenant Structures: The corrugated metal riser and outlet pipe were in good condition except for the heavy coating of surface rust on the metal strainer and corrosion at the outlet end.

PHOTO 1. Outlet Pipe at Toe of Embankment

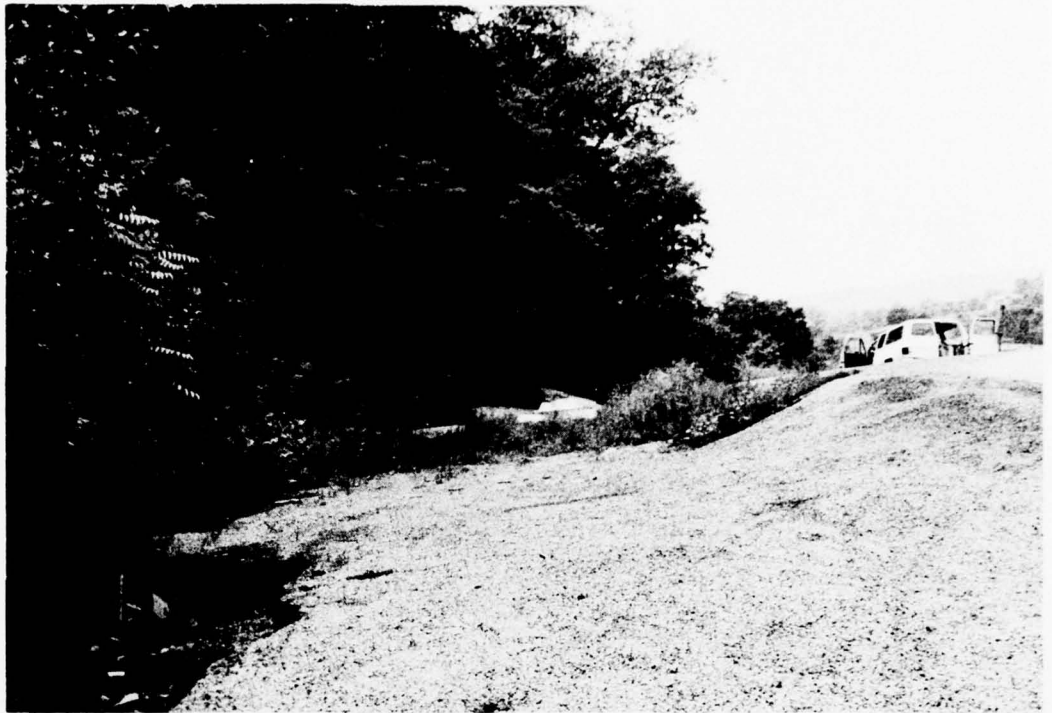
The emergency spillway is severely eroded on its downstream sections where it parallels the road (Photos 3, 4 and 5).

**PHOTO 3. Looking Upstream at Emergency Spillway
From About 100 Feet Downstream**

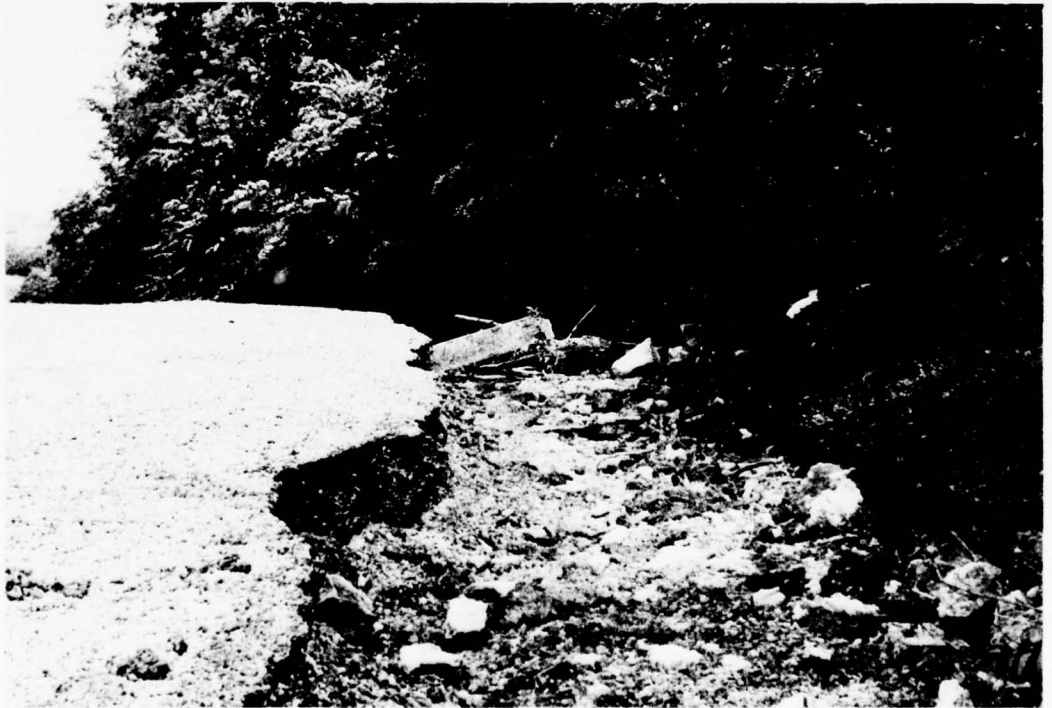
**PHOTO 4. Looking Downstream at Emergency Spillway,
100 Feet Downstream From Crest**

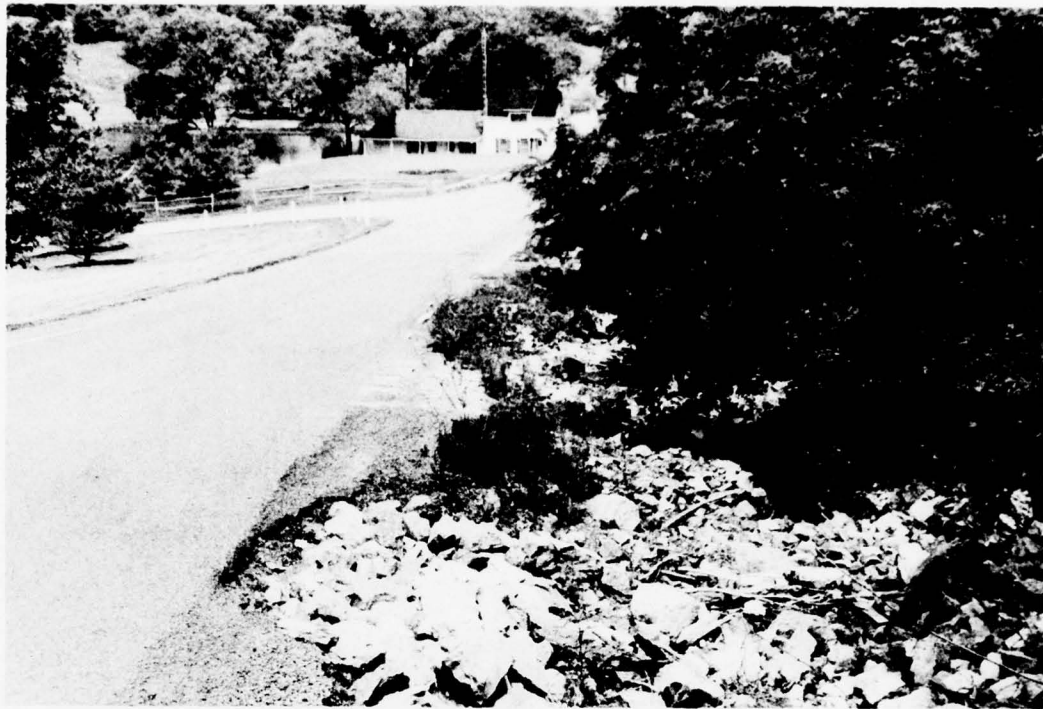
**PHOTO 5. Looking Downstream at Emergency Spillway
From Point in Line With Centerline Bearing**

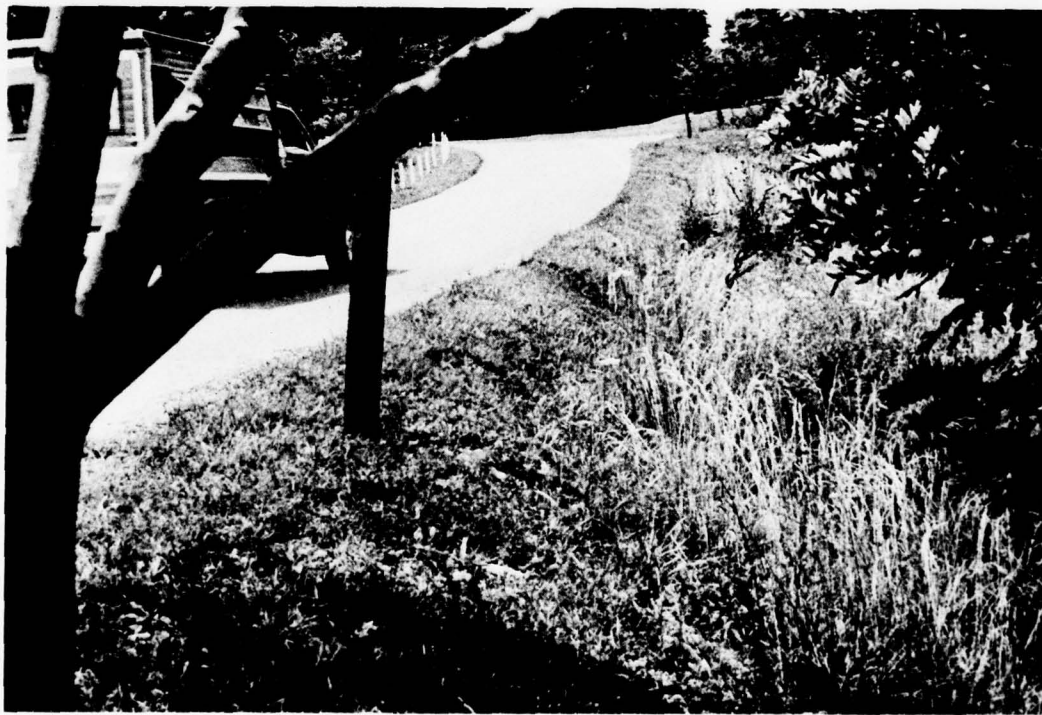
- 1) An old shallow slide, approximately 50 feet in length, was found near the crest of the dam on the downstream face. It is located approximately 250 feet to the left of the 15 inch diameter spillway outlet. The scarp is vegetated, but the slide mass has steep slopes and appears to be unstable. Seepage was not evident at this location.

6.3 Evaluation: The dam appeared to have been constructed with slope ratios of 2.5:1 on the downstream side and 3:1 on the upstream side. No tension cracks were observed. Evidence of an old shallow slide was observed on the downstream slope, about 250 feet to the left of the outlet pipe. The vegetated scarp is located near the crest of the dam and has a length of about 50 feet. The slide mass below the scarp appeared to be unstable with steep slopes. Seepage was not noticed at this location. It is recommended that this area should be repaired and an attempt be made to define the failure surface and cause of the slide during the repair work.

PHOTO 6. Location of Sloughing at Top of Downstream Face (Looking Left)

- 1) The slide should be repaired and reseeded. An attempt should be made to determine its cause during the repair operation. No further investigation appears to be necessary at this time.
- 2) The wet area on the downstream face should be monitored to see if it becomes progressively worse and correlated with changes in the lake level. If the condition of this area significantly deteriorates, or if flowing water is observed; then a further investigation should be made.
- 3) The large marshy area should be further investigated to locate the source of its water. If it is

- 3) Repair and reseed the slide near the crest of the dam and assess the cause of the slide. A stability analysis may be necessary.
- 4) Monitor any changes in the soft area on the downstream face near the spillway outlet pipe. If flowing water is observed, further investigation is necessary to define the phreatic surface and assess piping potential and slope stability.

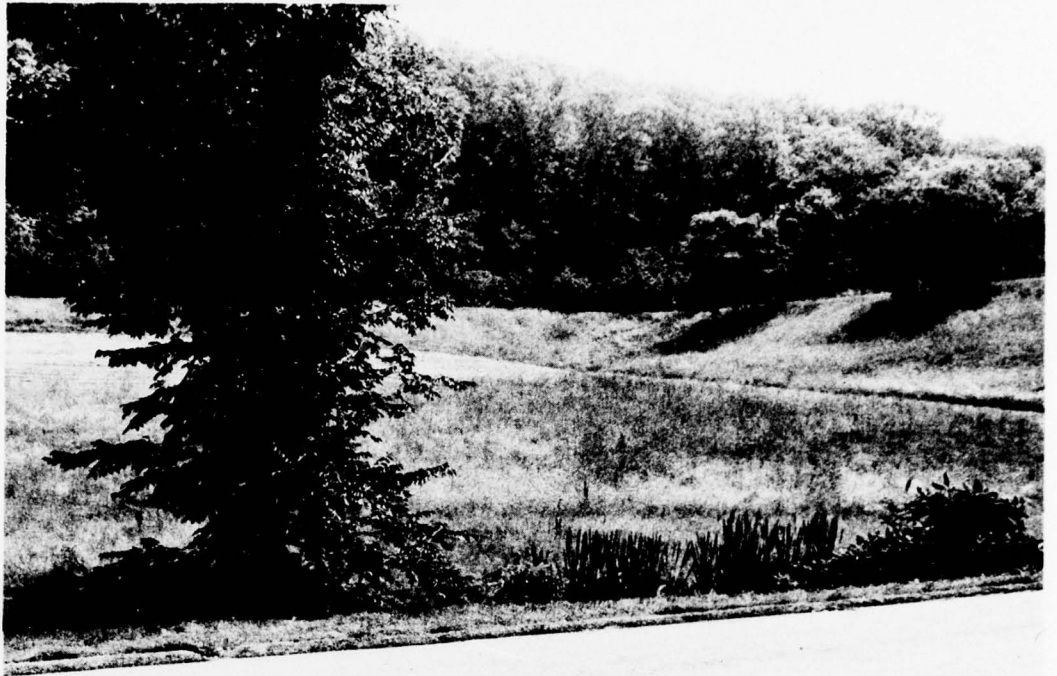
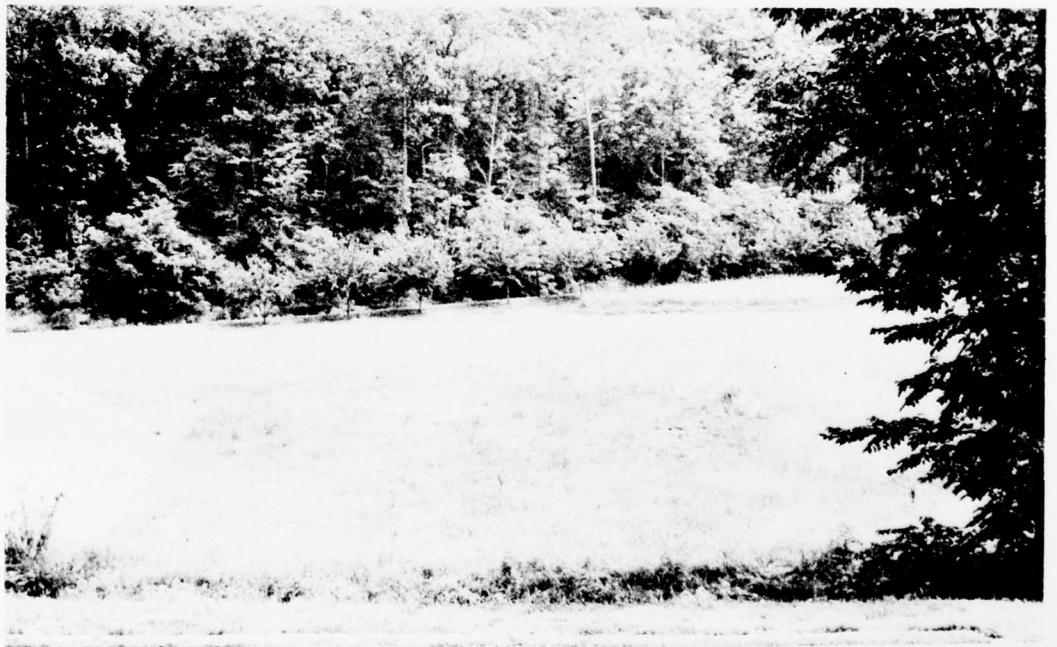
- 3) A large marshy area, approximately 150 feet by 100 feet, was located about 15 feet from the toe and to the right of the spillway outlet pipe. During the visual inspection, it was not possible to locate the source of this water.

The 150 feet by 100 feet marshy area located about 15 feet beyond the toe to the right (when facing the upstream slope) of the outlet channel represents an undesirable condition that requires further investigation. The source of the water in this area could not be determined by visual inspection. Therefore, the purpose of additional investigation by the owner would be to determine its source. If the source is found to be the reservoir, then it will be necessary to assess piping potential through the foundation.

**PHOTO 7. Swampy Area Just Downstream From Toe on Right Side of Embankment
(150 Feet by 100 Feet)**

**PHOTO 8. Swampy Area Just Downstream From Toe on Right Side of Embankment
(150 Feet By 100 Feet)**

determined that the reservoir is the source, then the piping potential of the foundation will need to be assessed. Correlation with lake levels is also recommended.
